Phase 1 Testing of a Homebuilt¹

Brian P. Lee, Ph. D., P.E.
Kent, WA

Abstract

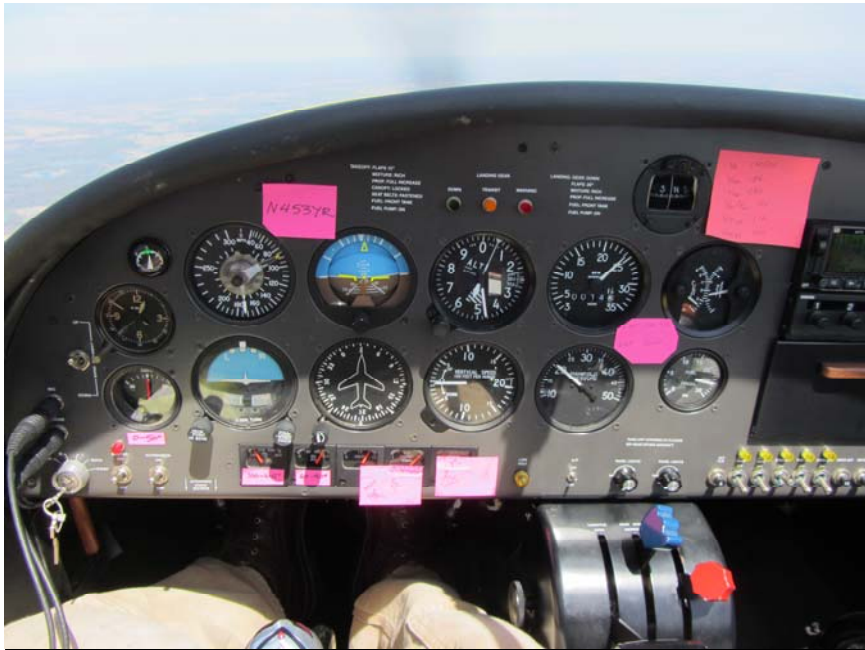
Figure 6. Temporary Placards

Since at this point, the instruments were not yet marked with range markers a great many post-it-notes with reminders for the pilot were posted all over the instrument panel (Figure 6). In addition to posting these, the pilot spent some considerable cockpit time in the hangar reviewing and annotating the kit

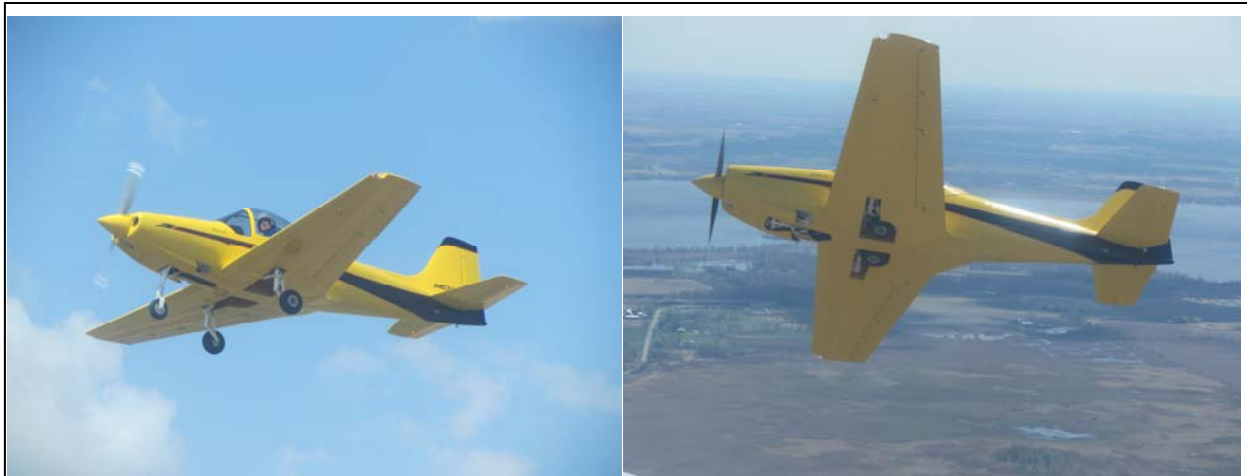
Figure 7. Flight 3, First Gear Retraction

A chase airplane was used for this flight, with the experienced Falco guru as an observer in the chase airplane. It was important to be able to examine the gear cycle, the gear in place in the wells. The gear was cycled 3 times, photos were taken (see Figure 7), and the chase was left for the speed envelope expansion evaluations.

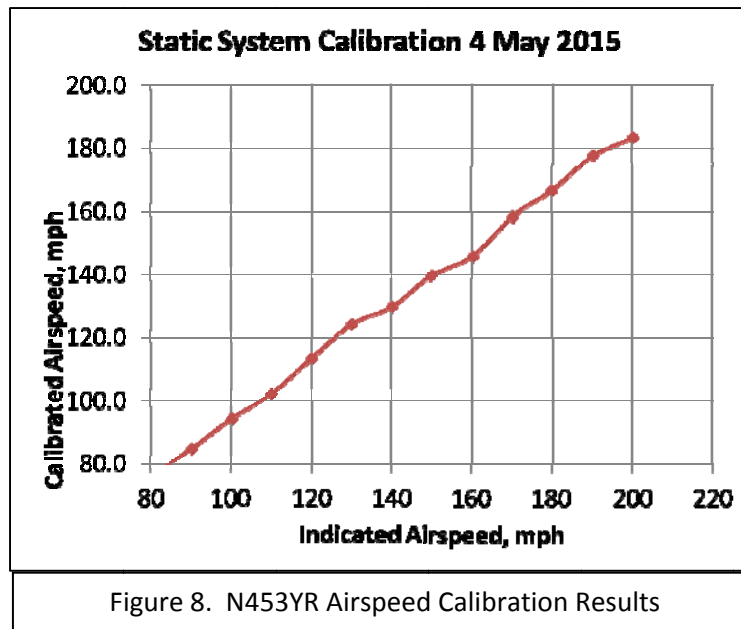
Figure 8. N453YR Airspeed Calibration Results

The airspeed calibration was conducted after the envelope expansion was complete and the gear doors were installed so the final aero configuration was stable. The first attempt was found to be contaminated by rough air, and the data was not all consistent. Smooth air the next morning produced better results, shown in Figure 8.

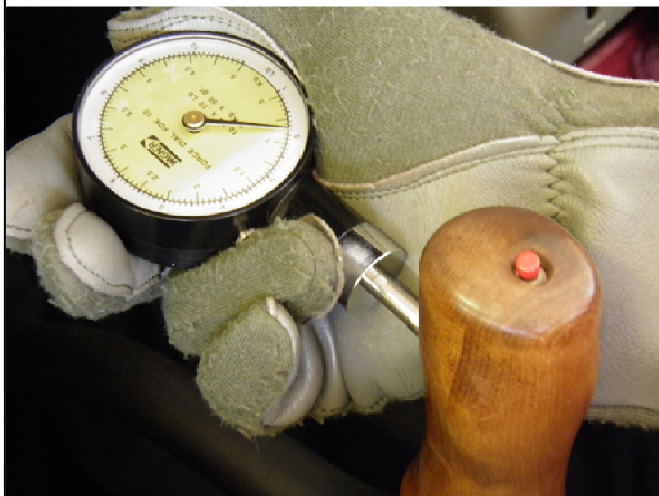
Figure 10. Measuring Static and Maneuver

Static Stability was measured by measuring the stick force required to stabilize on a speed 30 mph faster and 30 mph slower than the trim speed. Maneuver Stability was measured by measuring the stick force to hold 2 g's (1-g incremental) in a level 60 degree bank turn. Sometimes this took several times around the turn to get the condition stabilized and the force gage on the stick while monitoring for traffic, etc., but the technique worked, as illustrated in Figure 10.

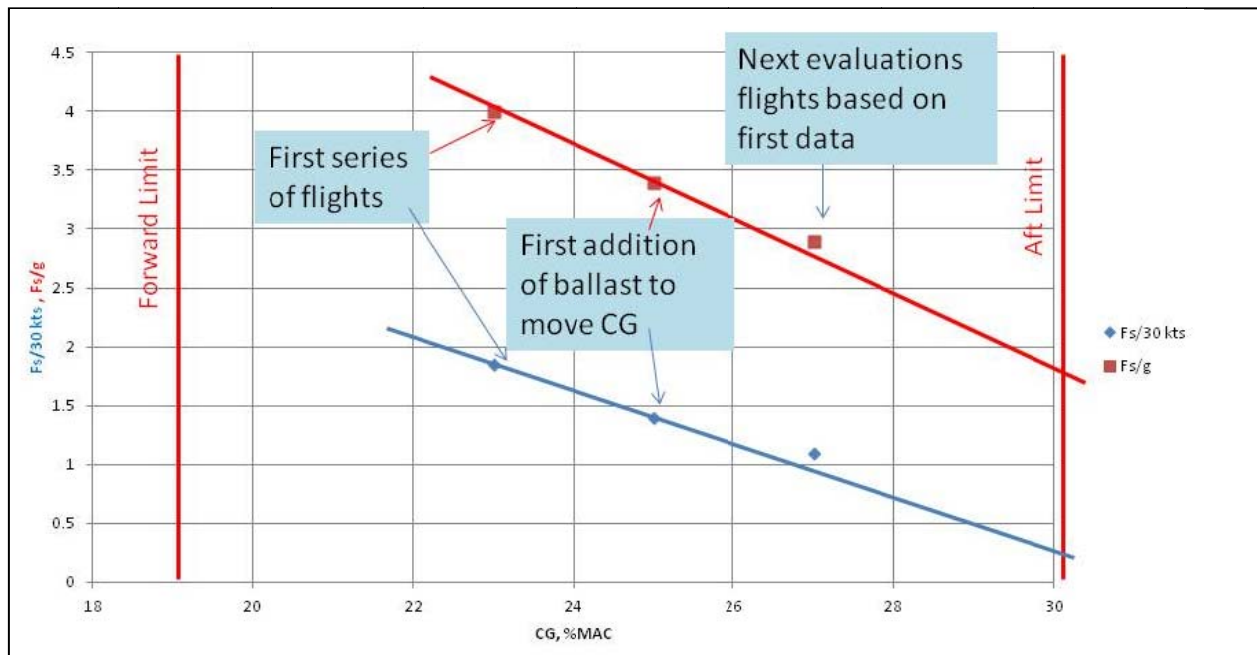
Figure 11. Static and Maneuver Stability Results

Following the measurements at the nominal CG used for the envelope expansion, the CG was moved aft and the measurements repeated. Extrapolation of those trends predicted close to zero stability at the kit manufacturer's aft limit, so a third set of measurements were taken prior to flying at the aft limit. The results of these measurements are shown in Figure 11.

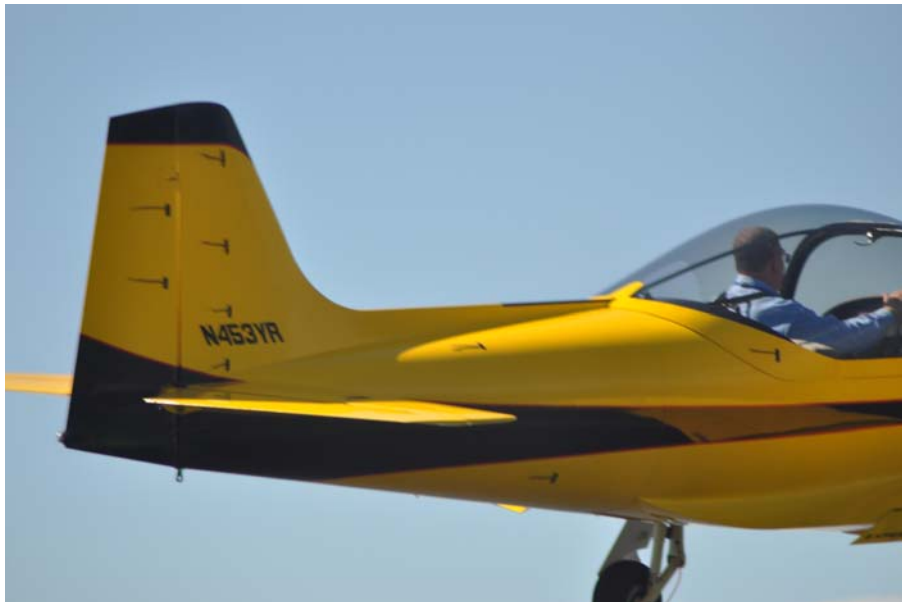
Since the anomaly was only seen with Left pedal, the right side of the vertical tail and rudder were tufted (a quick trip to the local needlework store – black yarn on a yellow airplane worked well). As can be seen in Figure 12, there is no tendency for separation on the convex side of the vertical tail (rudder deflected away from the camera in this image), even though the chase pilot reported the tips of the horizontal moving ~2 inches during the buffeting. Again, the buffeting was only observed with gear down, all flap settings, nominal power at approach airspeeds.

Figure 12. No tendency for separation on the convex side of the vertical tail

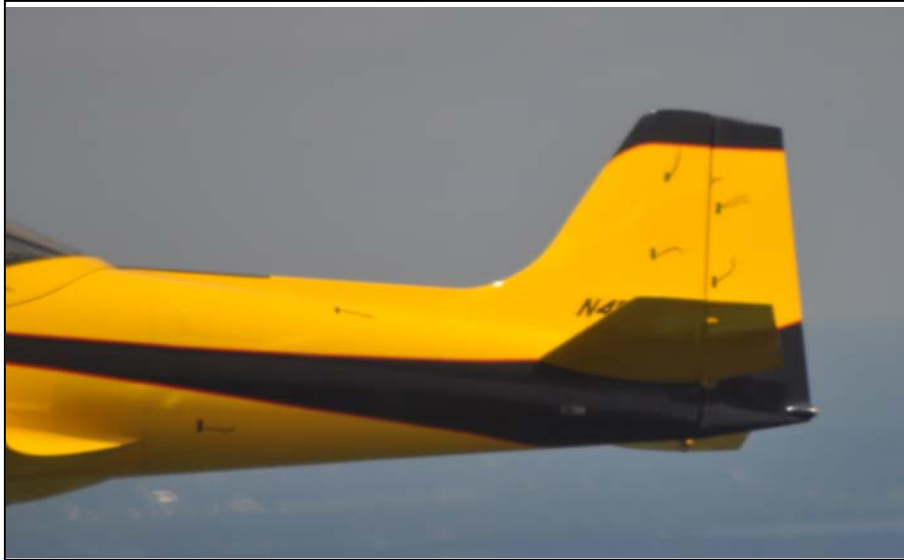
On the next flight, the other side of the vertical tail was tufted in the same way. The results are shown in Figure 13, the concave side of the vertical tail (rudder deflected towards the camera). The vertical tail and rudder is completely separated. That this condition might show up and present asymmetrically as it did is confirmed by Hoerner and Borst (Ref. 13) in their discussion of propeller slipstream effects on single engine airplanes.

Figure13. Separation on concave Side of Vertical Tail

Since there was no tendency to depart in the full pedal condition, the buffeting was seen as a nuisance feature, certainly not good for the structure over long periods of time, and not good for the pilots' comfort level. The decision was made to insert a shim in the rudder stop mechanism, to limit rudder deflection to the left. The size of the shim was selected to limit the sideslip to just below the large separation (and associated buffeting) condition. This was found to be not particularly limiting in terms of sideslip or crosswind capability.

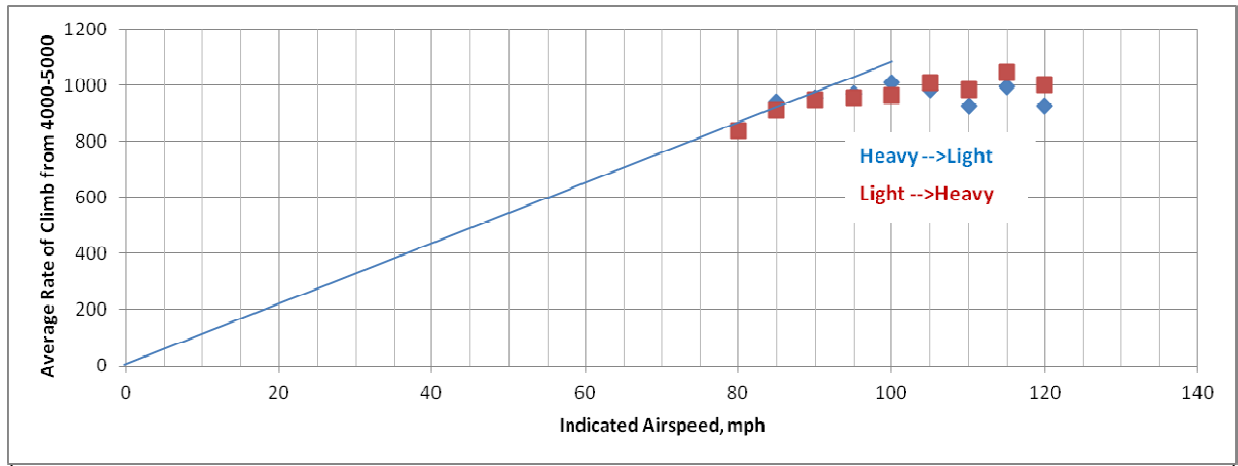
Figure 14. Climb Performance

Climb and glide performance testing was conducted to ascertain the best angle and rate of climb speeds and the best glide and minimum sink speeds. The testing was conducted perpendicular to the prevailing wind (which of course, first required determining the wind at test time), and involved climbing and descending through a 1000 foot block, timed with a stopwatch. This was a busy challenge to do single-pilot with only hand-held instrumentation. Each test point was flown twice on back-to-back flights with the airplane loaded to a heavy-weight forward CG condition: once starting at the high speed end of the

block, and once starting at the low speed end of the block, to account for the fuel burn during the testing. Climb results are shown in Figure 14.

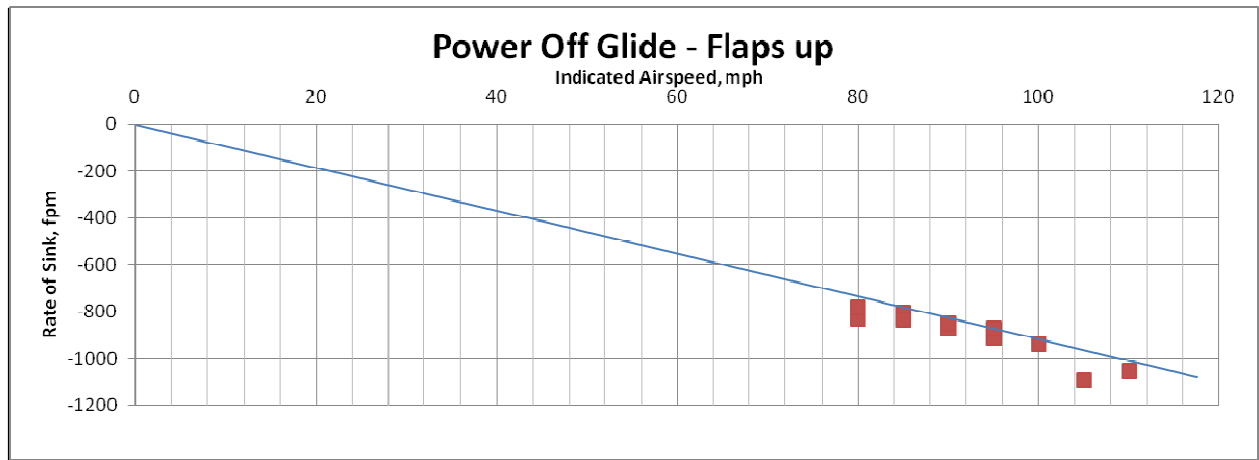
Figure 15. Power Off Glide Performance

Power off glide test results were obtained during the same flights. Results for speed for best glide and speed for minimum sink were determined from the same data, taken in the same way as the climb data. Power off glide test results are shown in Figure 15.
